Preliminary Thermographic Survey of Madame John's Legacy, New Orleans, LA

Michael Shoriak and Courtney Williams
Architectural Conservators

August 26, 2013

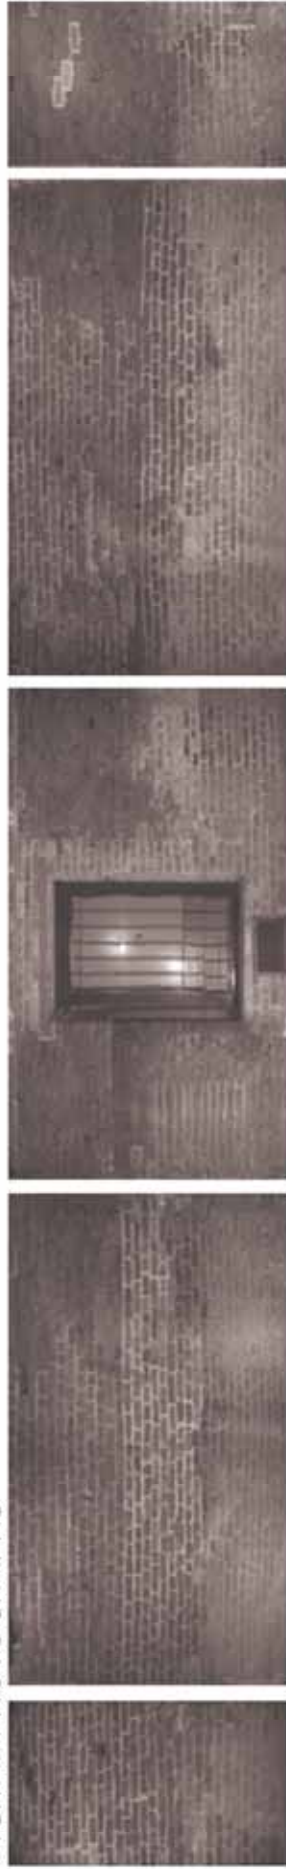
Drawing: Comparison between rectified wall elevation and merged thermal images

The following layouts depict surface temperatures on the five walls of room 281. All of the walls exhibit similar surface temperature patterns with the coolest portion of the wall surface being the base of each wall. The two long interior wall sections, 281-SE1 and 281-NW1, display the largest surface areas with temperatures below 81° F. Cooler temperatures are also found at the tops of these wall sections, possibly due to cool air falling from the climate controlled second level. The exterior wall in this room, wall section 281-SW1, has on average a higher surface temperature than the rest of the room. This is due to external heating of the exterior wall surface which has moved by conduction through the wall cavity to the interior wall surface. The highest surface temperatures are found on the test wall section 281-NE4. Continued monitoring of these wall sections using infrared thermography and sensor data will help to better understand the effect of the external environment on the location of moisture infiltration in the wall cavities under different environmental conditions.
